REVISED ANADROMOUS STREAM CATALOG OF SOUTHEASTERN ALASKA

District 106

Northeast Coast of Prince of Wales Island

Subdistricts 106-30 and 106-10

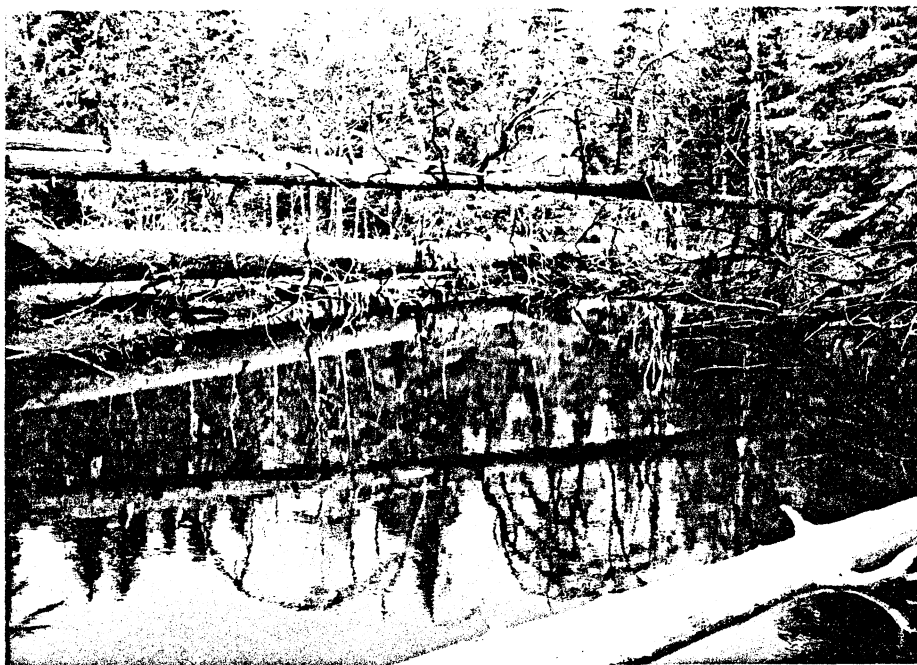
5. Section 8: Logging debris and beaver activity create an extensive rearing impoundment.

Section 8: 68m; A remnant beaver dam demarcates Reach 3. Channel diverges around a debris and brush covered "island". The right channel is characterized by deep pools, copious debris, and a muck substrate. An extensive clearcut unit borders the left channel which typically contains dense debris and "pockets" of suitable spawning substrate. 200m; Beaver dam in ill repair creates an extensive rearing impoundment.

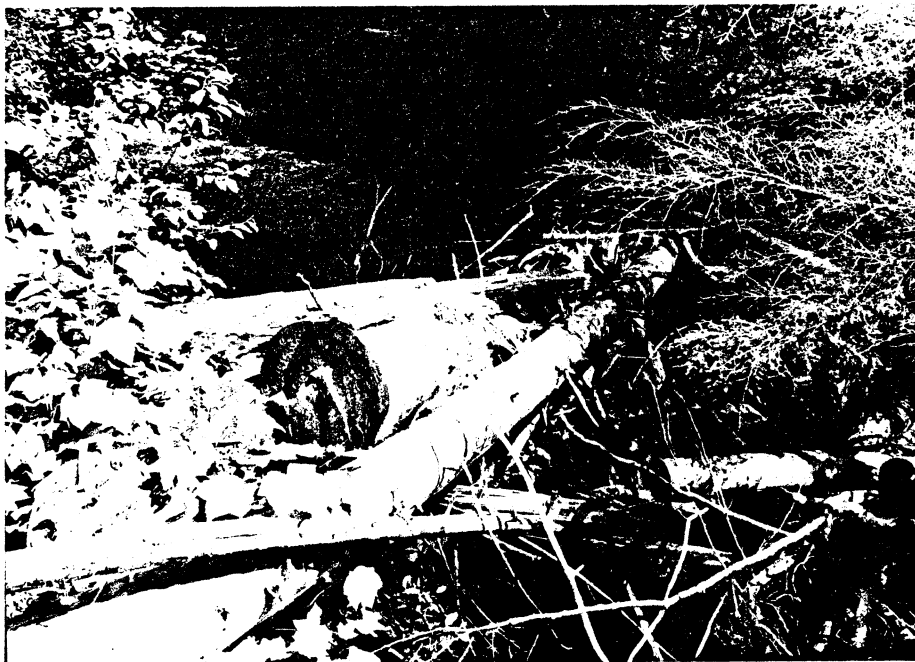
6. Section 10: Debris jam represents a potential low flow barrier.

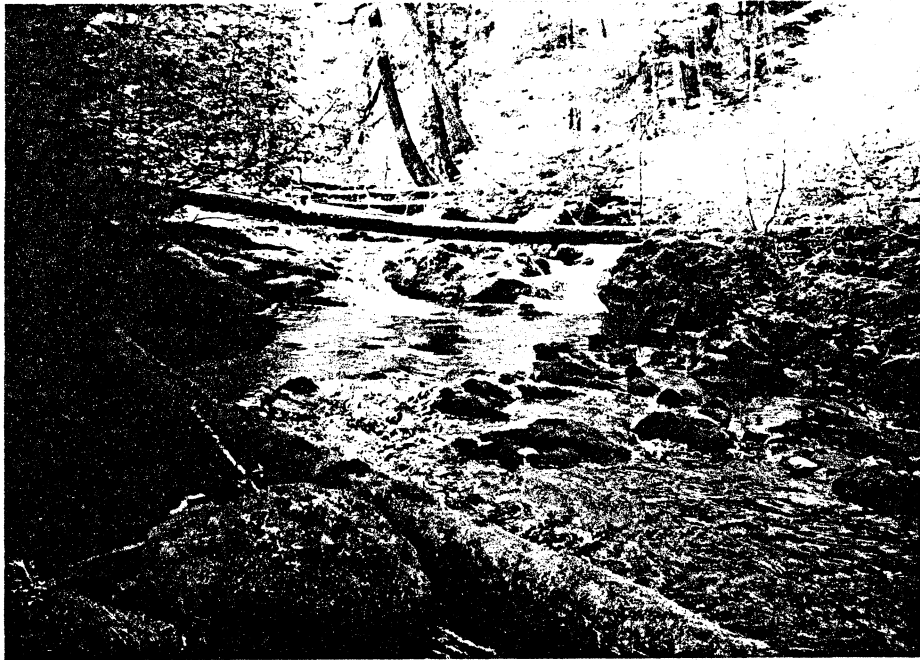
7. Section 15: Channel negotiates a V-notch via boulder/bedrock cascades.

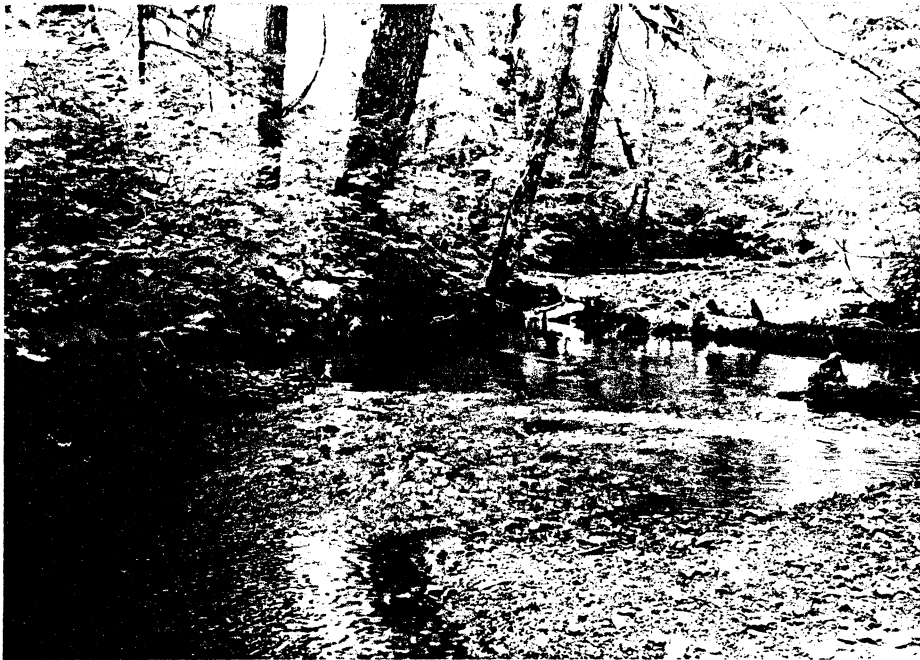
8. Section 23: Between V-notches gradient is reduced and gravel/cobble riffles provide excellent ASA.

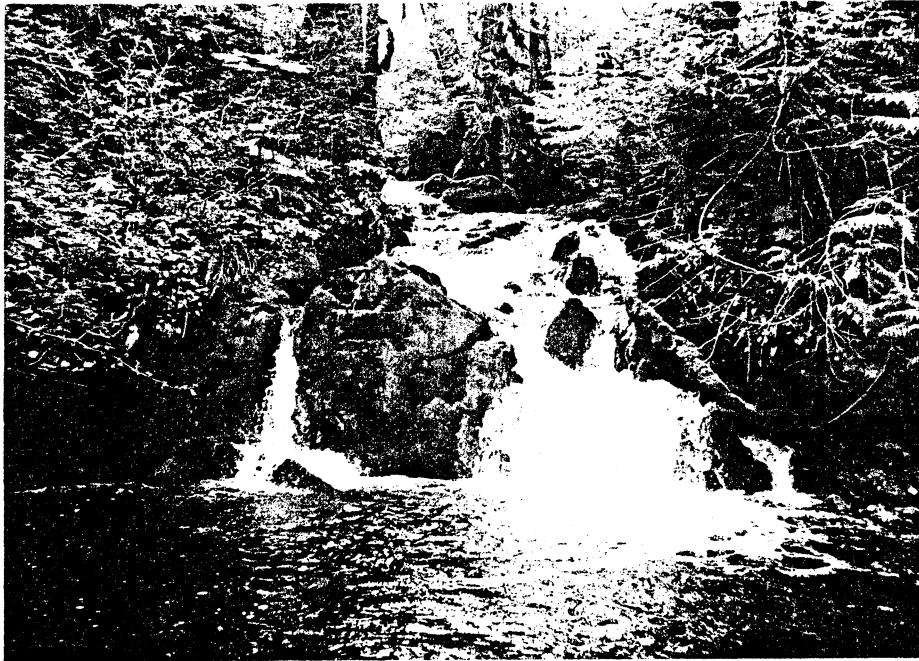
9. Section 32: A 3.0 vertical meter bedrock falls followed by 9.0 meters of high velocity cascade creates an effective migratory barrier.

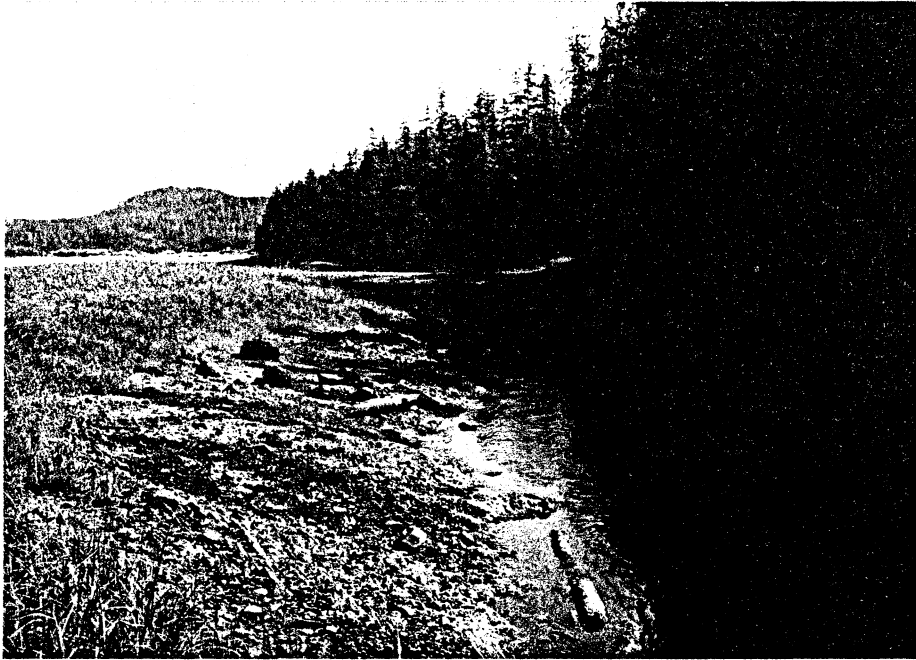
1. An extensive ITZ drains into a lagoon providing excellent holding and rearing habitat.

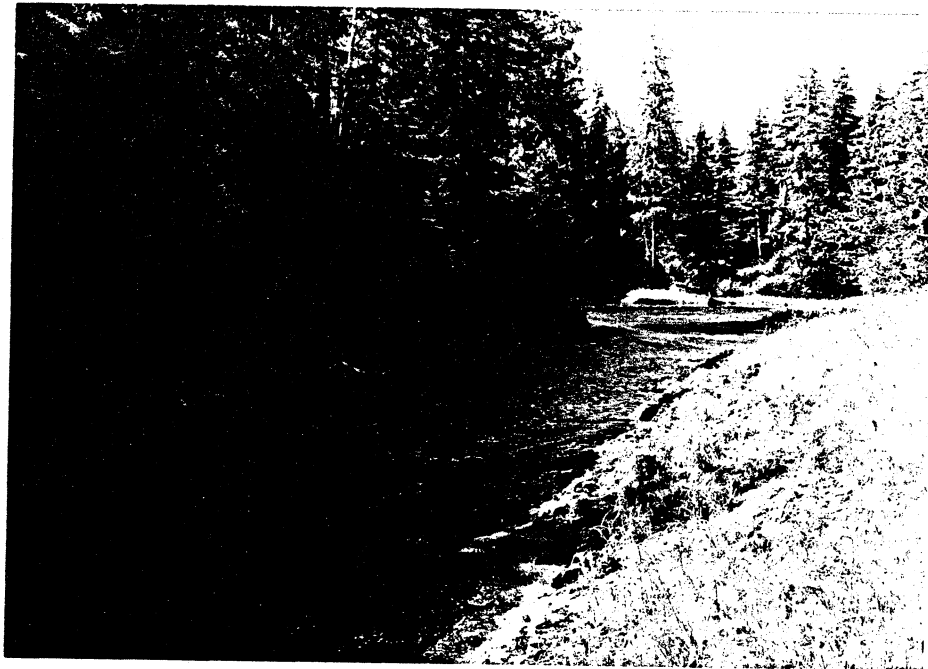
2. View of mid ITZ. The bulk of PS spawning occurs below this point and a migration barrier occurs approximately 150 m upstream.

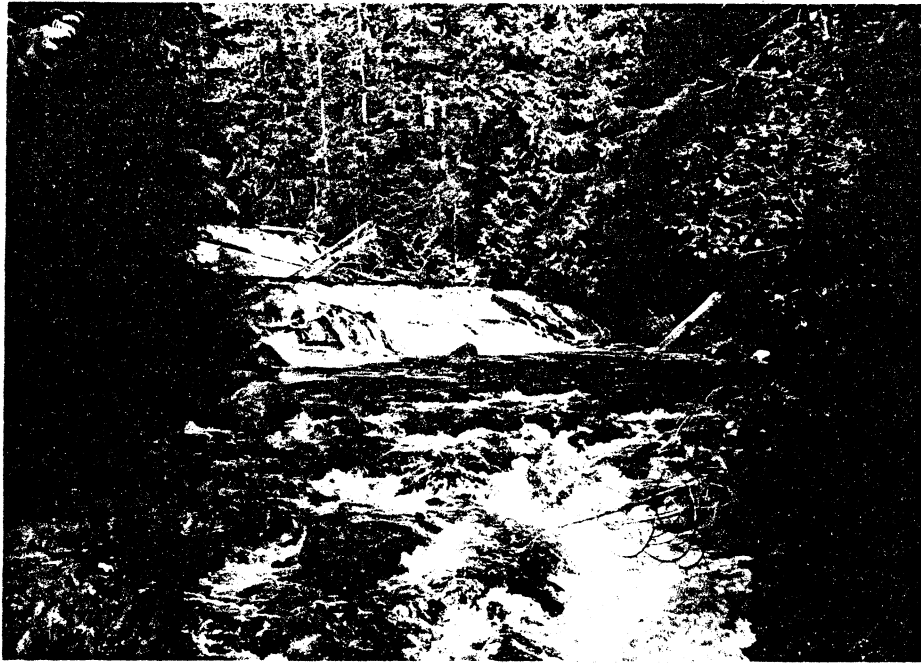
3. Section 1: The ITZ ends at the base of these 5 and 7 vertical meter bedrock barrier falls.

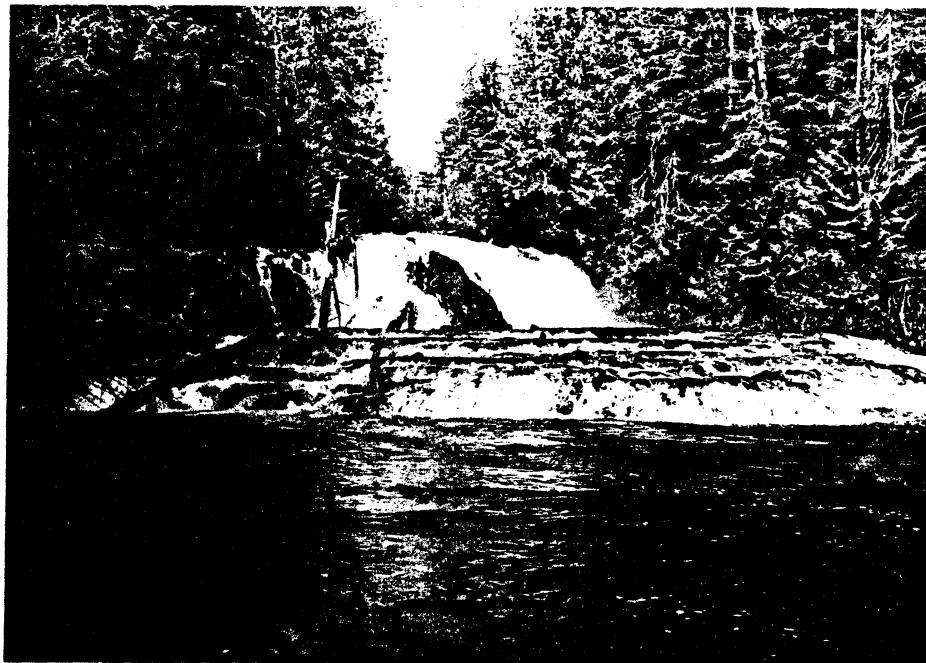
4. Section 2: Bedrock stair-step cascades culminate in a 12 vertical meter barrier falls.

Section 2: A 12 vertical meter barrier falls delineates the lower extent of Section 2. Above the falls, the bedrock/boulder channel becomes a uniform progression of tiered cascades. No spawning habitat was observed and marginal rearing was confined to peripheral boulder pools (Photos 4 & 5).

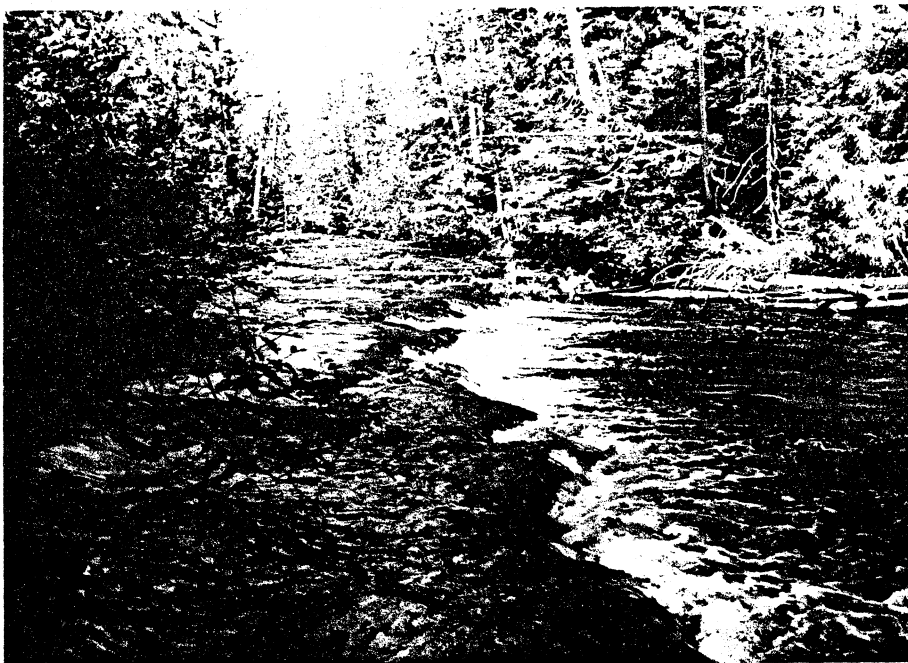
5. Section 2: Above barrier channel becomes a uniform progression of tiered cascades. Minimal rearing and no spawning habitat observed.

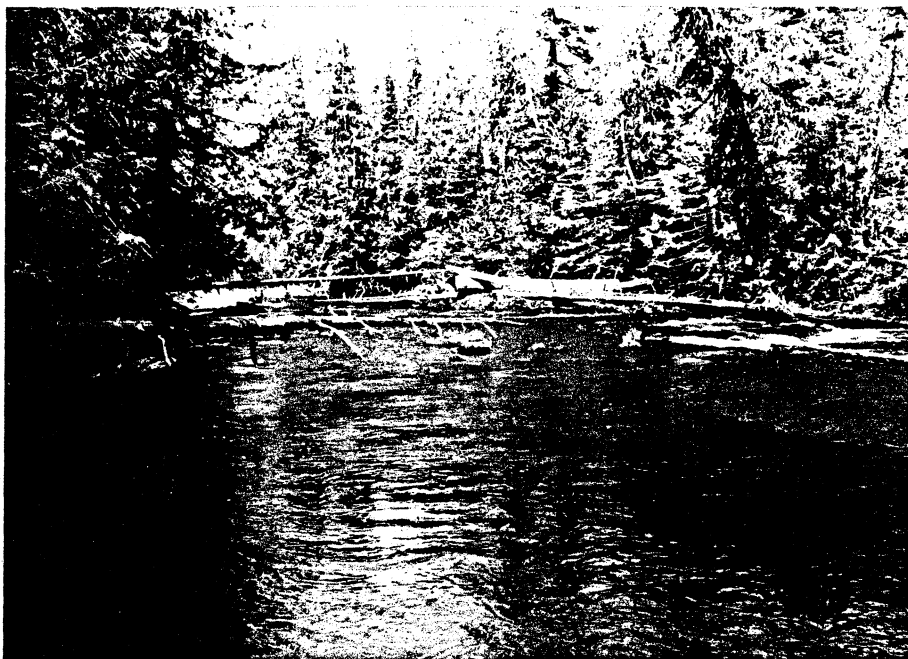
6. Section 4: View beyond Section 4 to lake confluence, left center. Aquatic moss and deep, slow pools provide limited rearing along left bank.

Section 3-4: A bedrock/boulder channel and typically fast flow provides marginal and extremely limited rearing habitat. No fish or ASA were observed. Aquatic moss and deep, slow pools provide limited rearing near lake confluence (Photo 6).

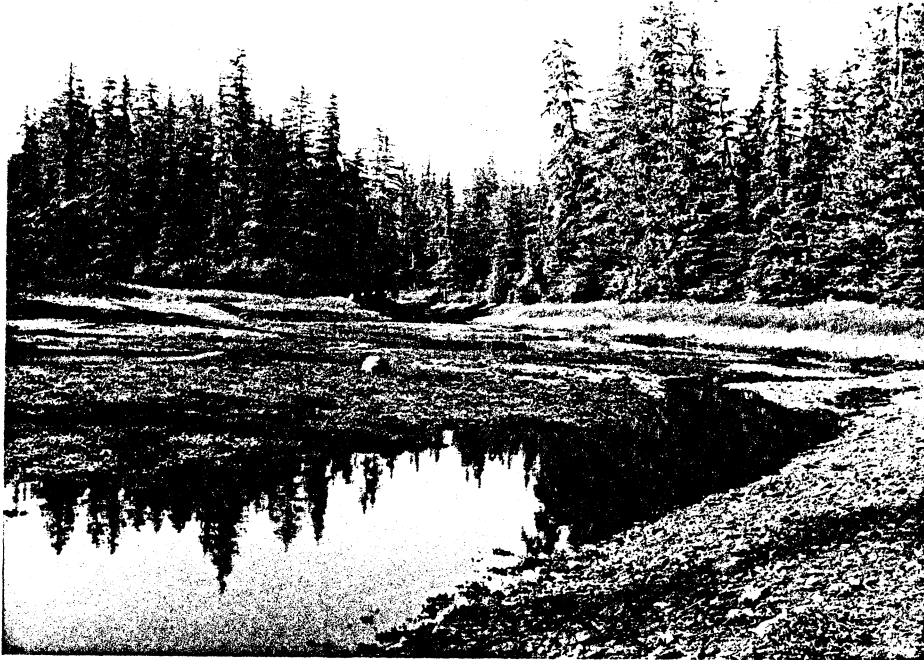
1. Lower ITZ of Whale Pass #3.

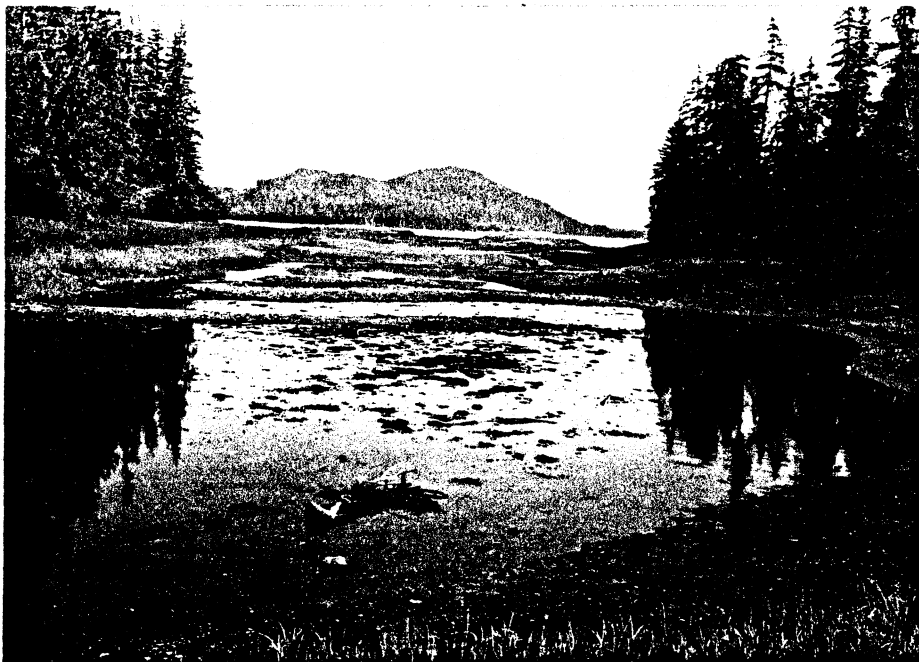
2. Downstream view of lower ITZ with rearing pond.

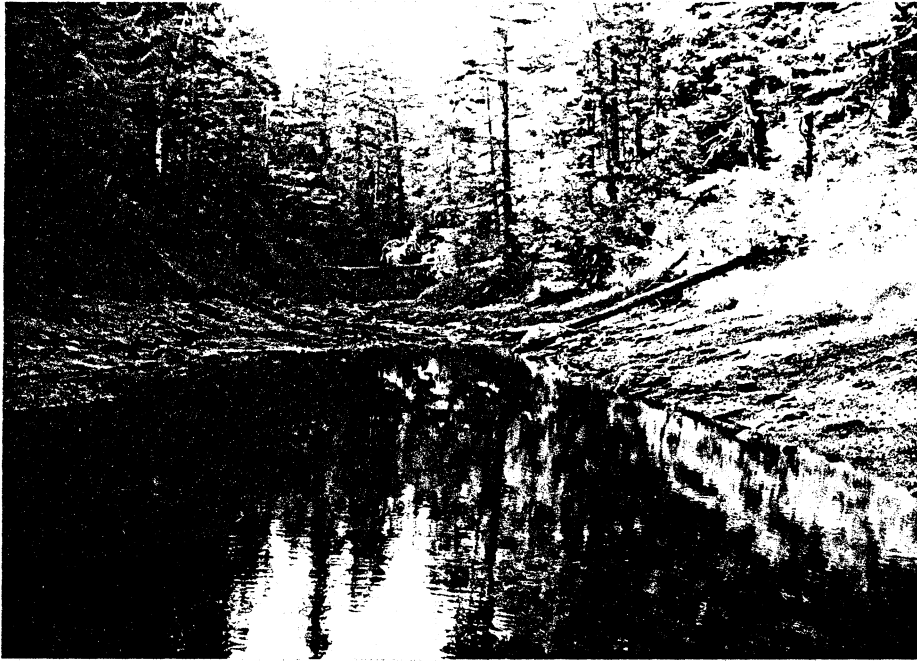
3. Upper ITZ and mouth of stream.

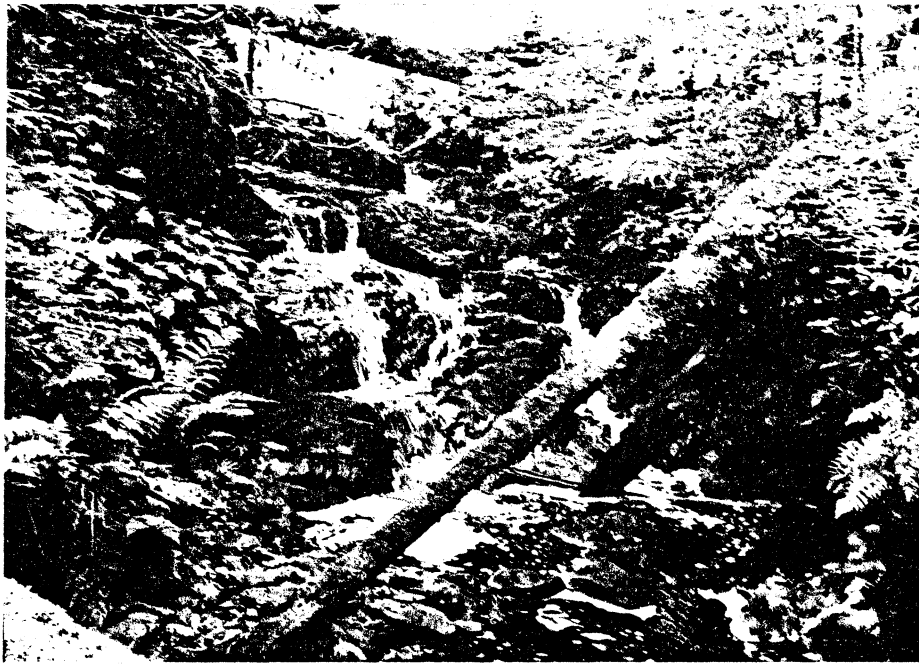
5. Barrier cascade at Section 14: 100m with 25% gradient for 20m.

The stream is of a sluggish nature with low velocity, instream forbs and considerable aquatic vegetation on the substrate. Consequently, fish habitat is of poor quality. No salmon fry were observed in the stream, only trout (cutthroat/DV fry and one adult DV). Windthrown areas are common throughout the stream. A barrier cascade at Section 14: 100m concludes the survey.

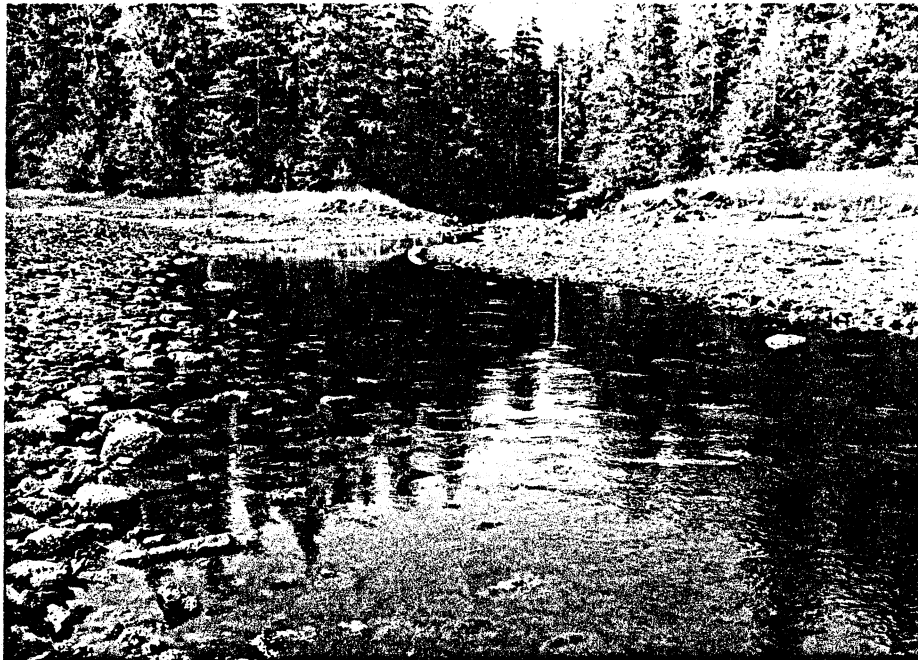
1. The ITZ looking toward the creek mouth.

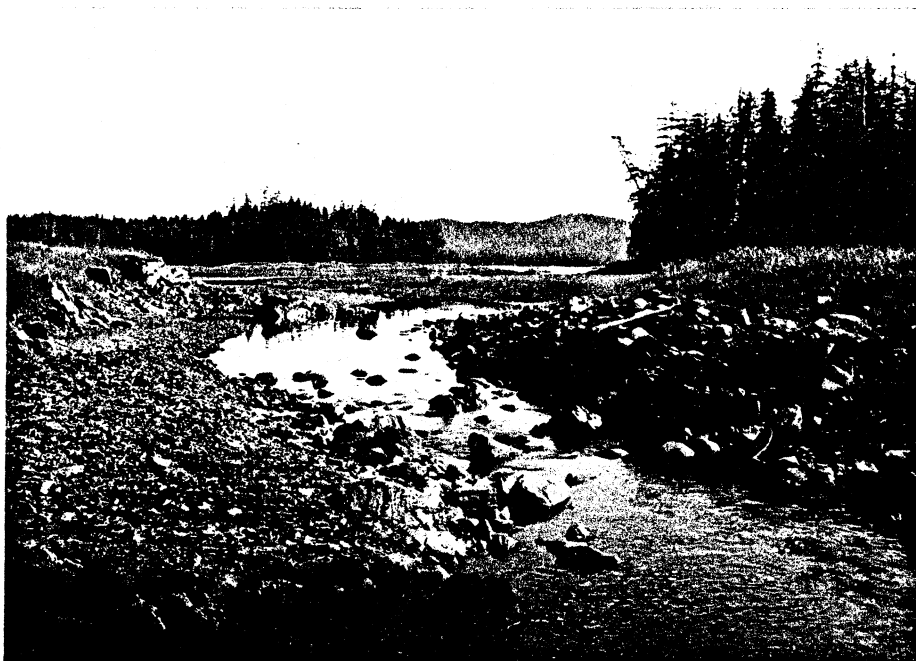
2. The ITZ looking downstream over Rocky Bay.

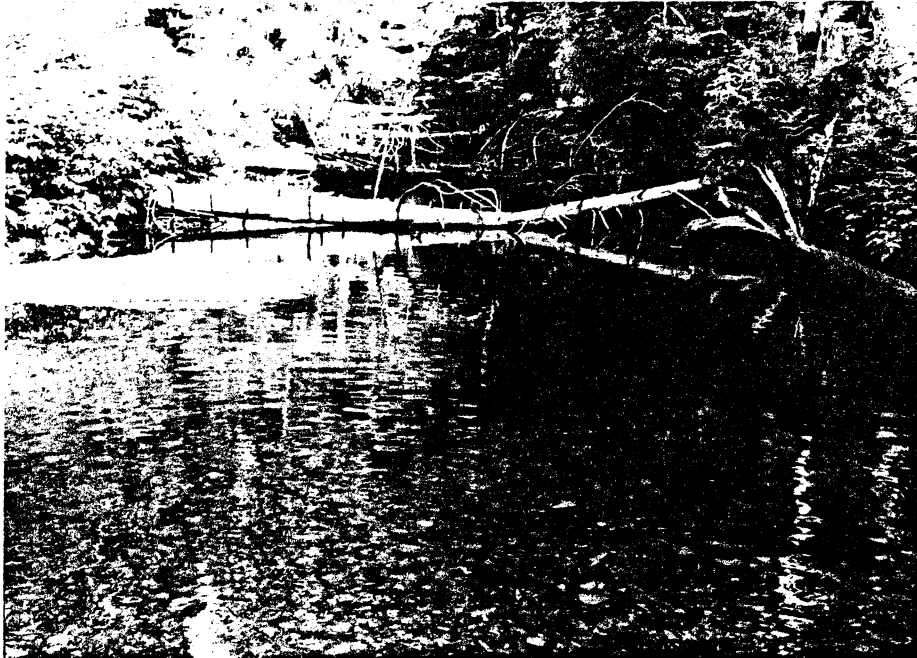
3. Section 5: Moderate debris loading and large, deep pools provide good rearing habitat.

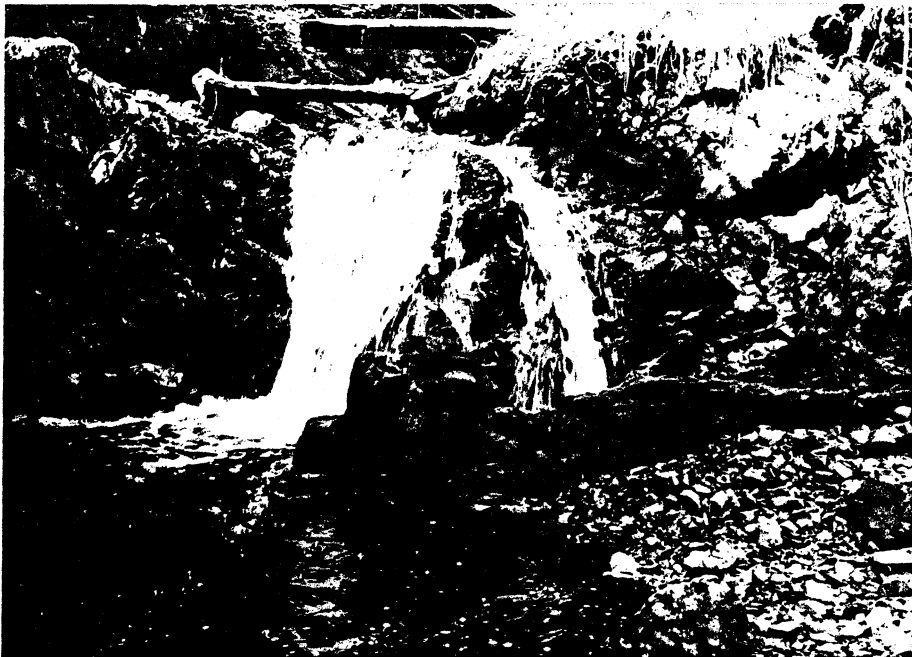
4. The third of 3 two meter falls in Section 8. A potential barrier to pink and chum salmon.

Section 8: Substrate is predominantly bedrock. Gradient is very steep as the stream travels through a V-notch. A series of 3 two meter falls probably block migration of adult pink and chum salmon upstream. Coho fry were found above this section.

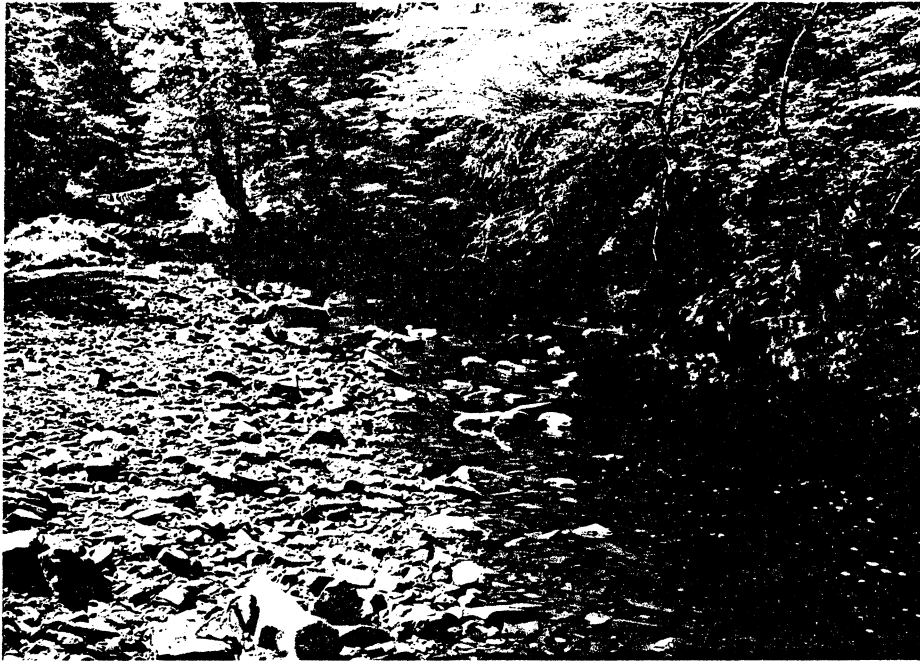
5. Section 9: Good fish habitat just above the falls.

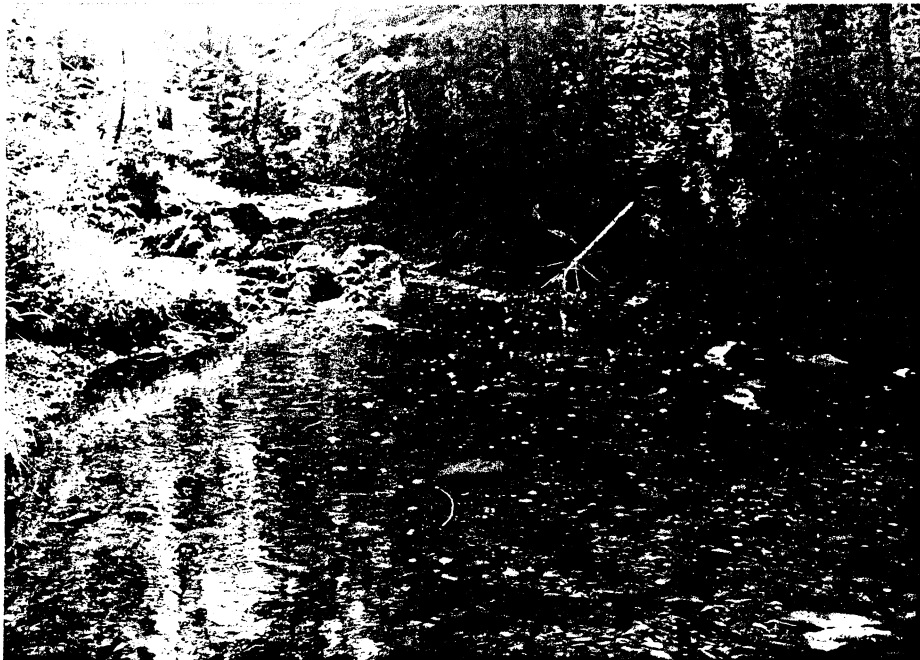
6. Section 16: Substrate consists largely of small cobble and gravel. A large bedrock outcrop is visible in the background.

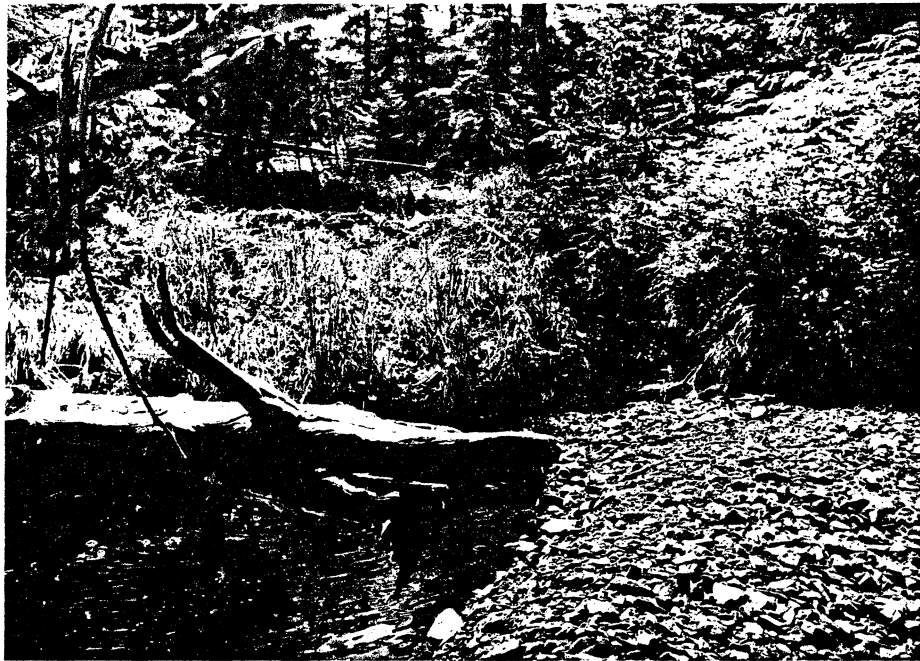
7. A large beaver system enters the left bank of Section 16.

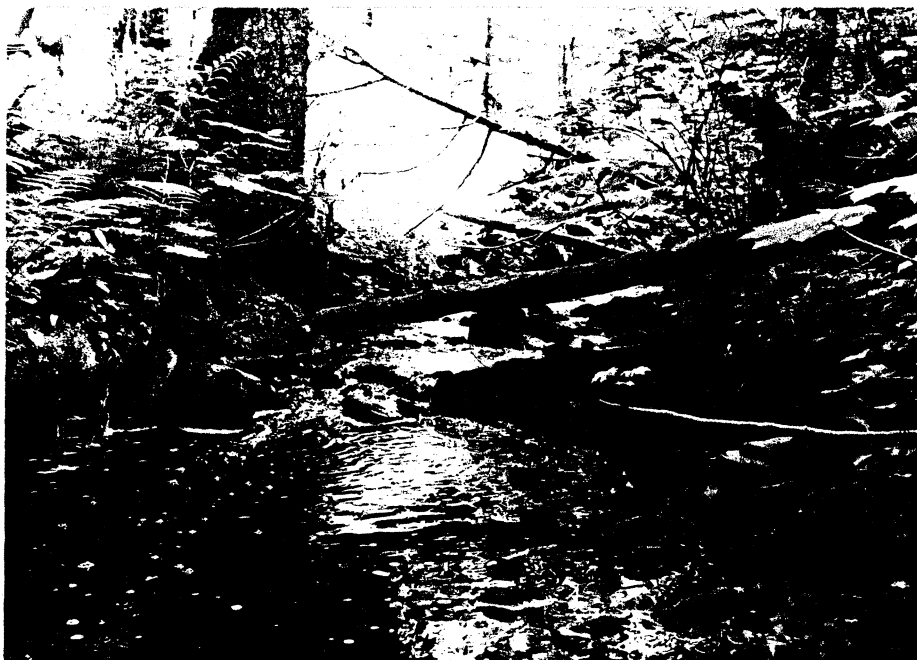
2. Substrate consists largely of large cobble, boulder and bedrock.

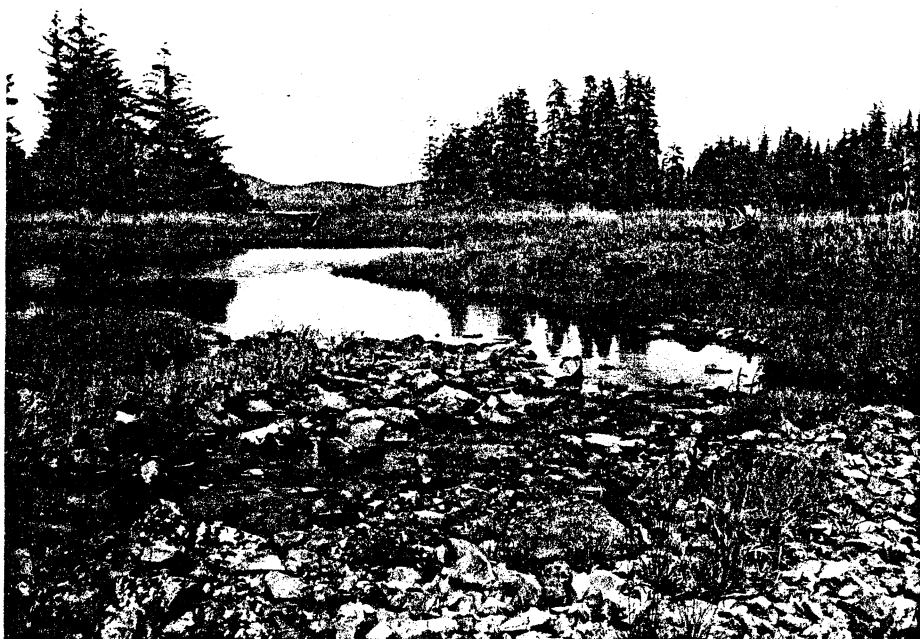
1. Interface of the boulder strewn upper ITZ and a small tidal lagoon.

ITZ: Survey was performed near high tide. A bedrock cascade delineates the upper extent of the ITZ and fractured bedrock/boulders typify that portion of the ITZ visible at time of survey. 12 SS fry were observed rearing in peripheral bedrock pools. An extensive, revegetated clearcut extends to both banks (Photo 1 and 2).

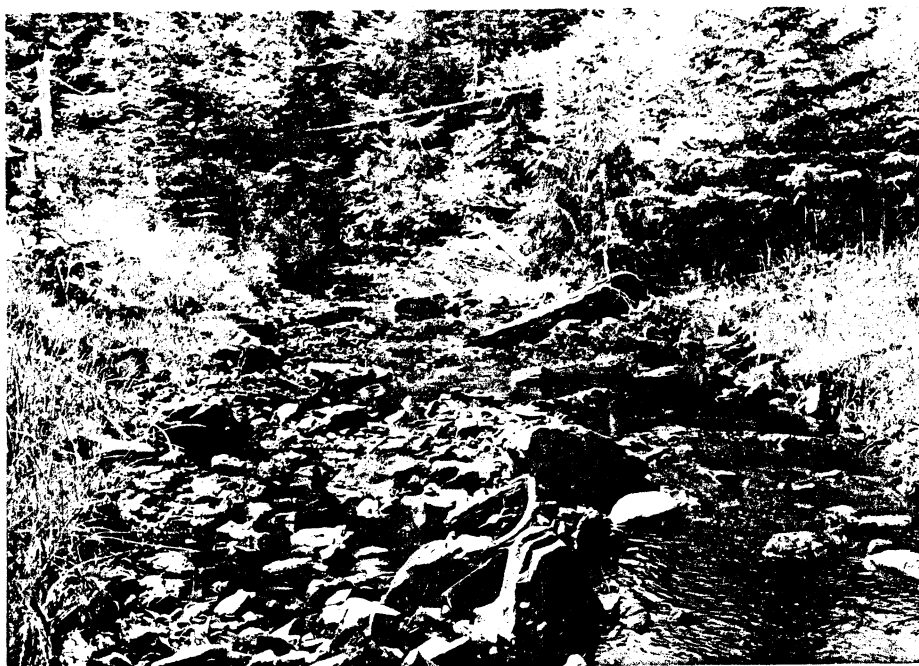
2. The upper ITZ is characterized by bedrock chutes and boulder riffles. A clearcut unit extends to both banks.

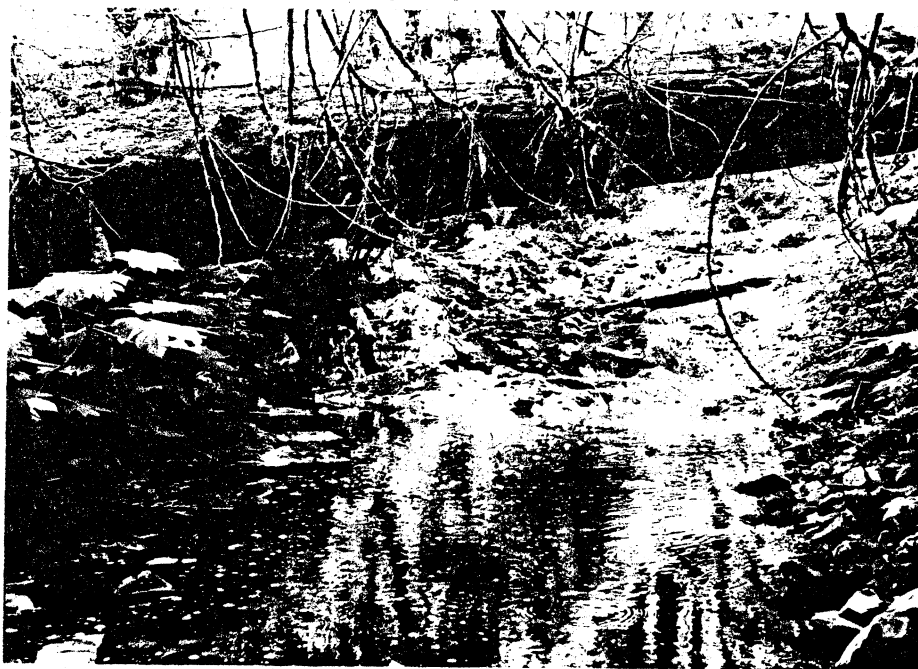
3. Bedrock cascades, logging debris and pools containing angular cobble provide limited rearing and marginal isolated spawning.

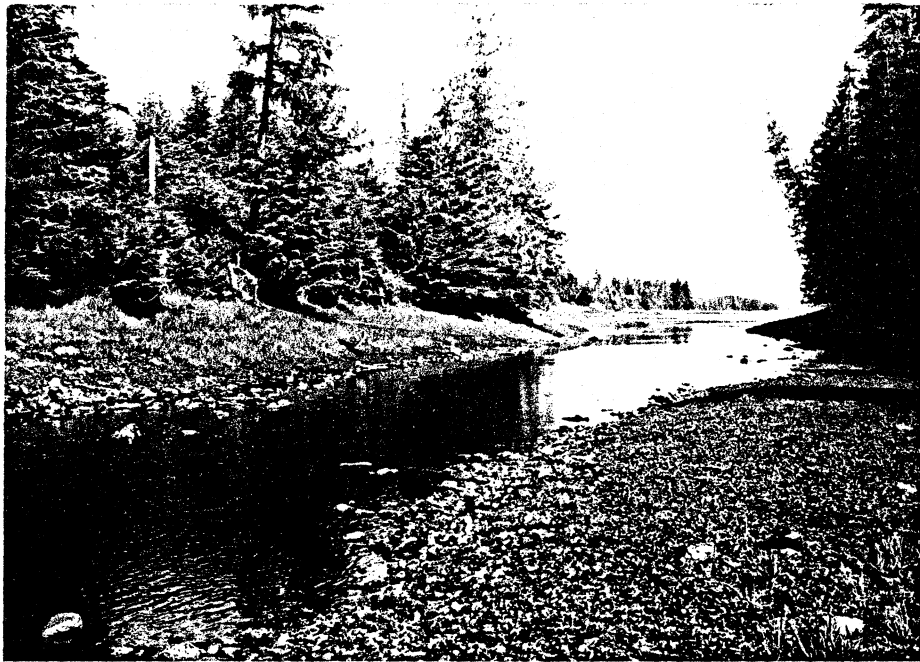
1. View down lower ITZ toward Whale Pass. An extensive revegetated clearcut extends along a portion of the right bank.

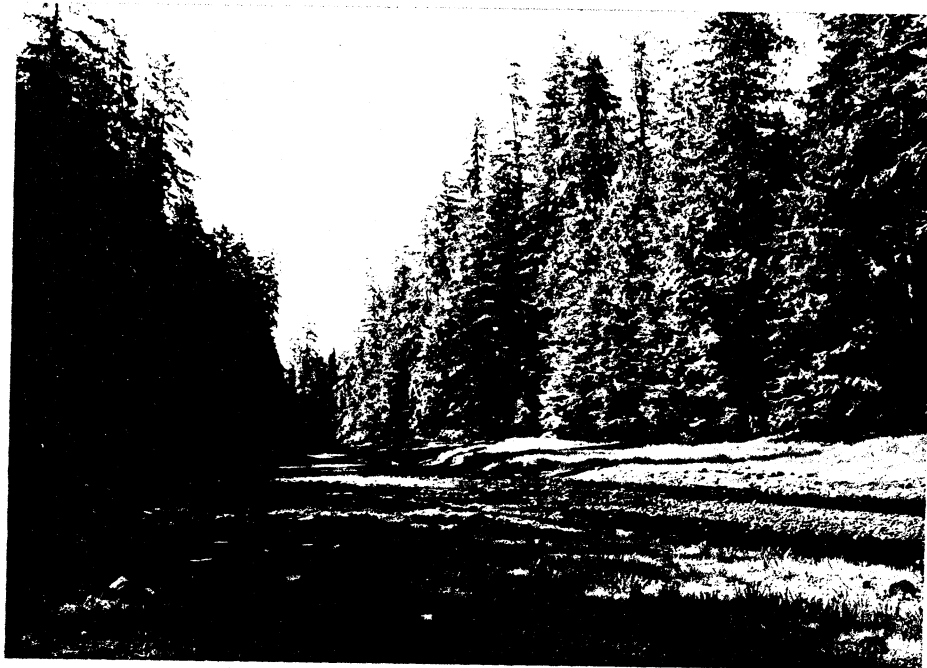
2. View up mid ITZ. Old growth timber lines both banks.

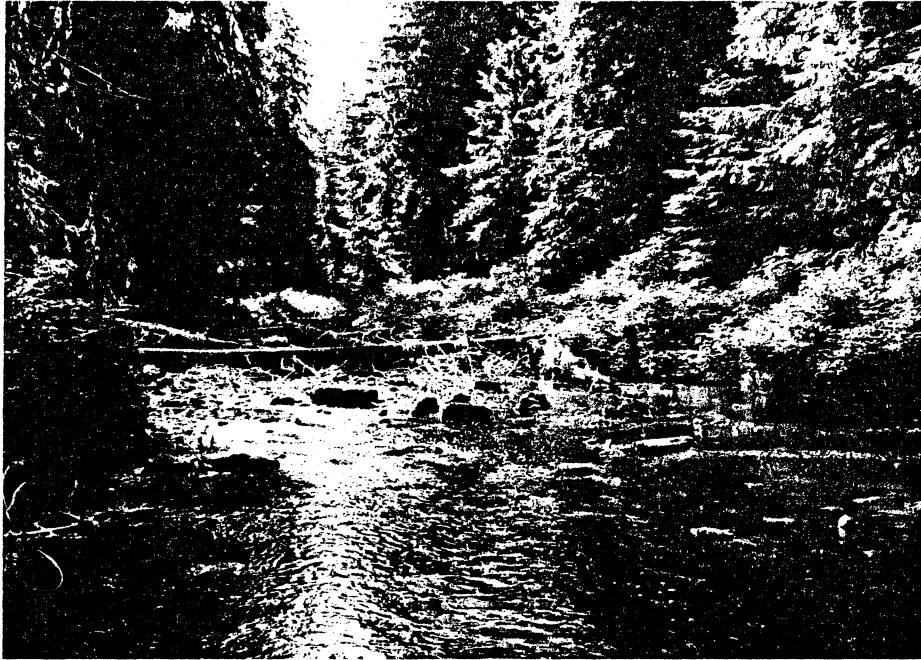
3. Section 3: Cobble riffles provide moderate spawning habitat. Abundant instream moss and skunk cabbage attest to typically low, stable summer flows.

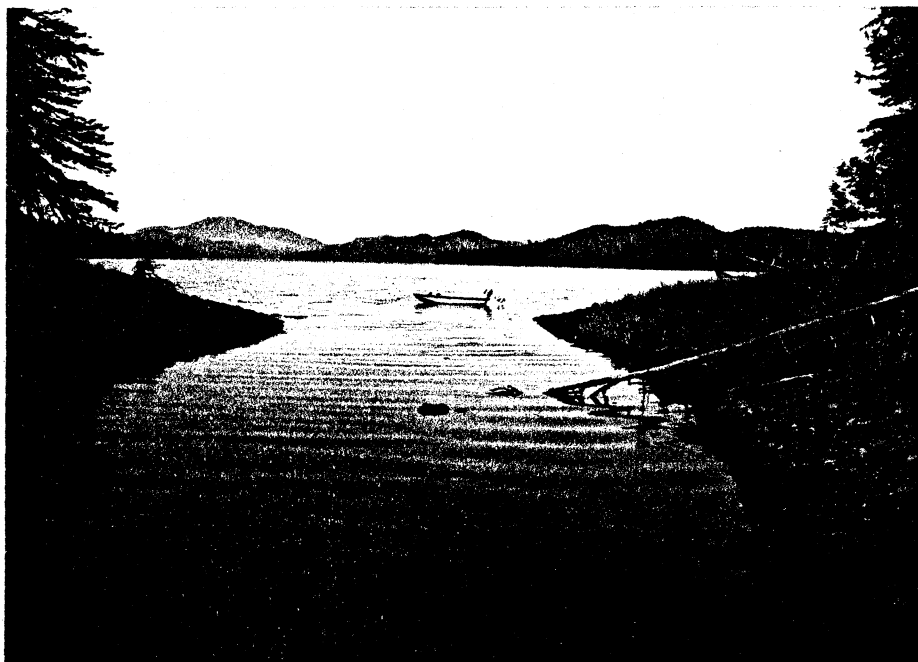
2. Downstream view of lower ITZ toward Whale Pass.

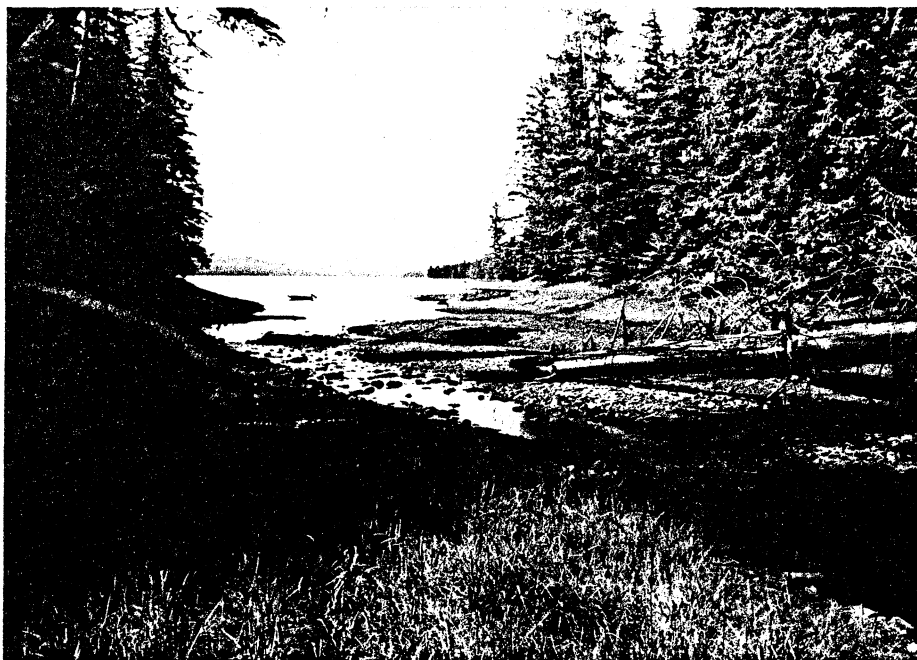
1. Downstream view of ITZ toward Whale Pass.

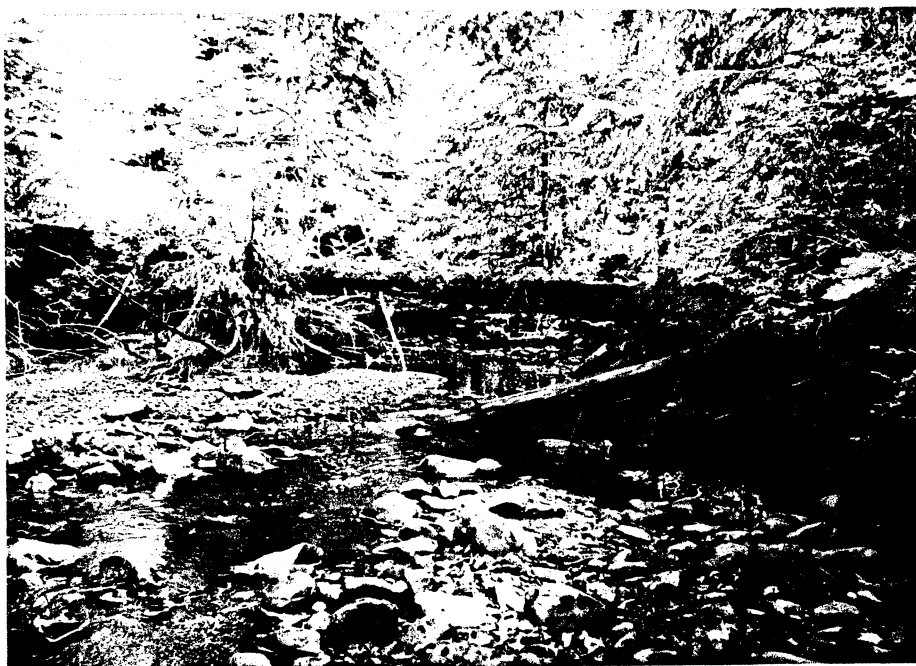
2. Mouth of Whale Pass #1 with blowdown.

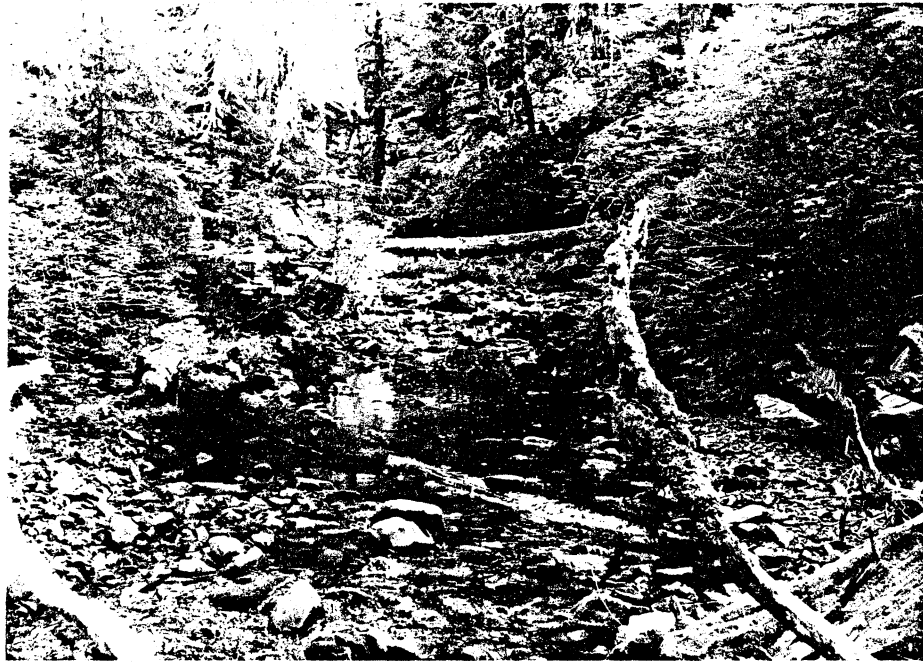
3. Section 2: 40m; Stream flow over boulder/cobble with steep banks and windthrow.
